**Discover Your Streams:
Sing Sing Kill, Stewardship for a Small Hudson River Tributary and into the Tide.**

Interim Status Report UPDATE for
DEC01-HRER16-2015-00032
Contract # DEC01-T00131GG-3350000

Updated 11/14/2017

Hudson Valley Arts and Science
53 Old Albany Post Road
Ossining, NY 10562
(914) 954-9447

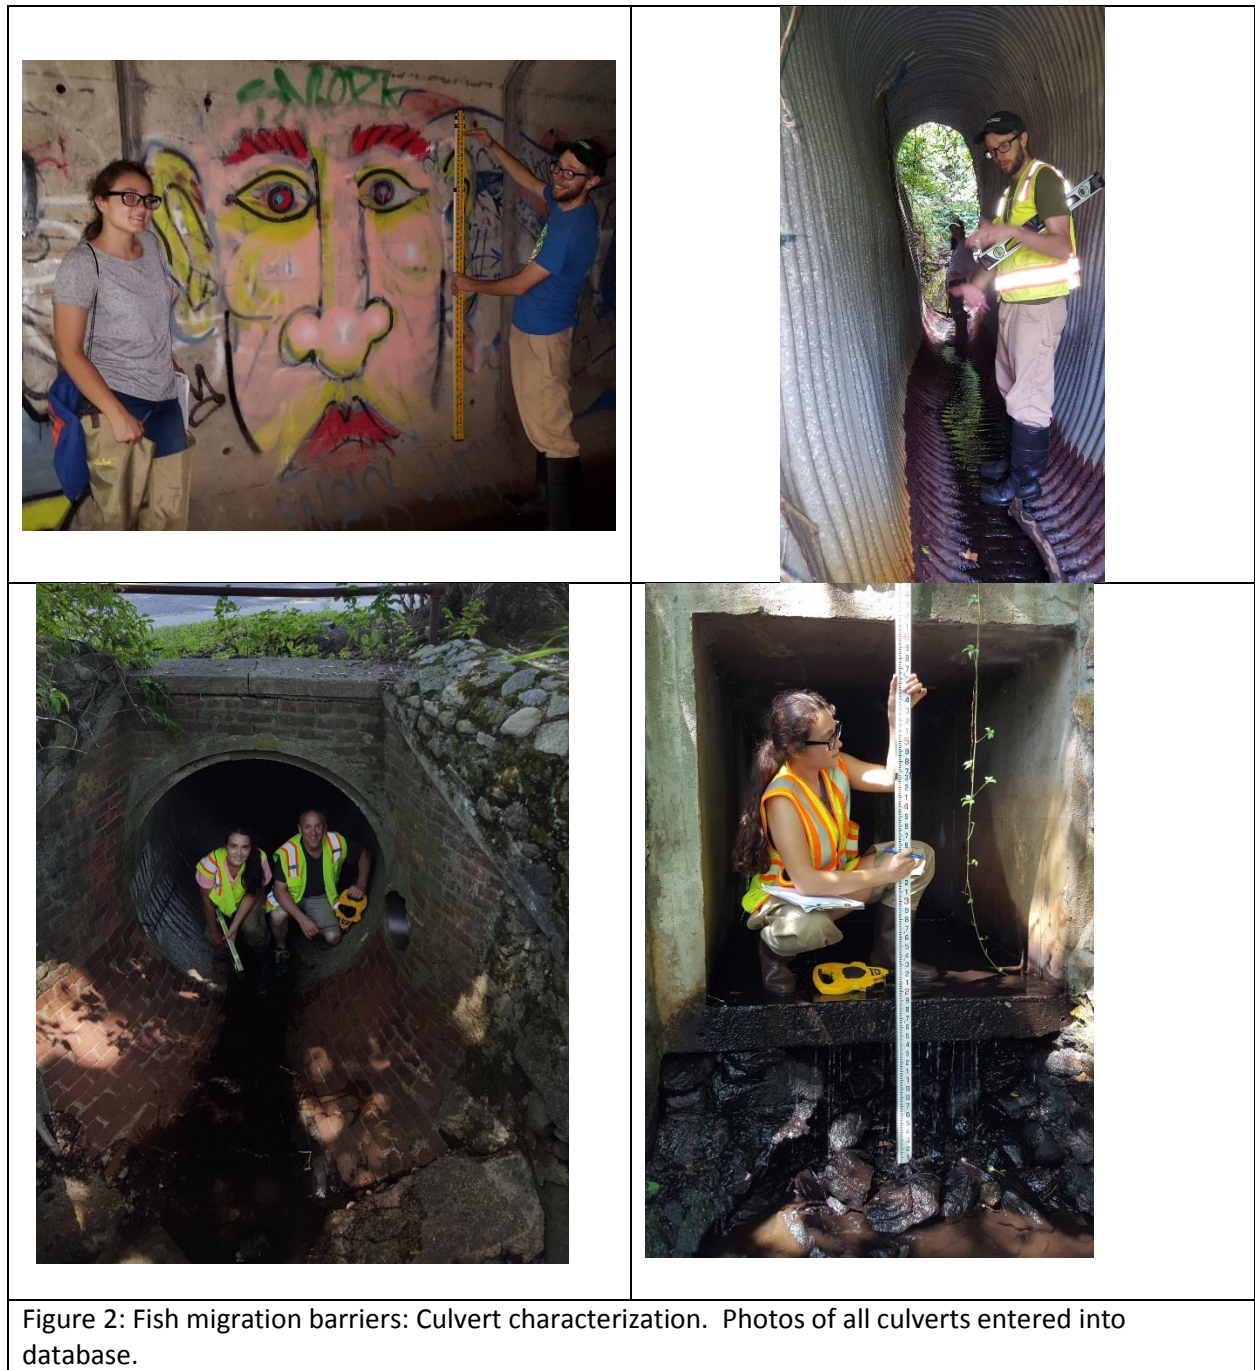
Summary: G.Hougham and C.Wieber received culvert training from Andrew Meyer of the NYS DEC on 07/08/2016 and have since characterized and reported on 62 culverts and bridges. See figures 1a and 1b. Details can be found at www.streamcontinuity.org in the database link on the left margin and by searching for culverts input by C. Wieber and G. Hougham. Two high priority barriers have been identified in the lower portions of the Sing Sing Kill (SSK) and are candidates for mitigation proposals in the future.

Figure 2: Fish migration barriers: Culvert characterization. Photos of all culverts entered into database.

Future action: The two most significant AOP barriers are at the Croton Aqueduct Double Arches, just below the stream gauge, and 200 meters farther downstream. Both could potentially be mitigated for fish passage by filling with rip rap or installation of fish ladders. We are considering writing a grant proposal for the design and permitting of these mitigations with the hope for construction in a future year as funding permits.

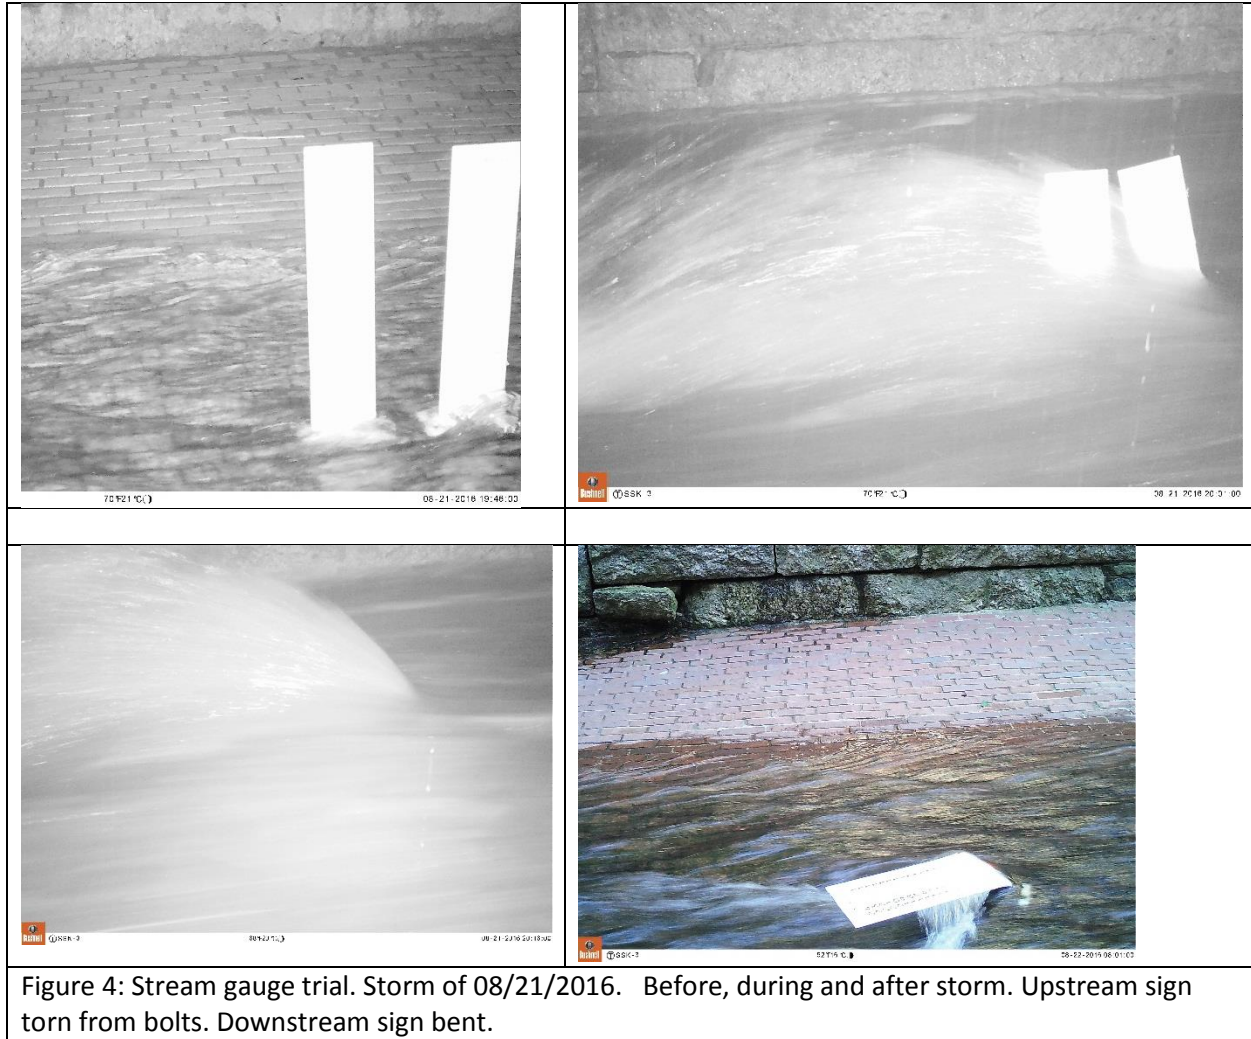
A variety of sign arrangements and physical attachment methods were tried. Some failed and these led to improvements. Design changes are still being experimented with. The two main problems encountered were 1) leaf and debris entrapment against the sign making the depth numbers difficult to read in the photographs with accuracy because of excessive turbulence and spraying. This was significantly reduced by installing another sign six inches upstream to act as a debris deflector and catcher. This helped considerably but did not eliminate the problem. 2) Large debris including floating logs and rolling boulders were observed in heavy storm events which threaten to destroy mounted signs midstream. (Such may have contributed to the sign destruction during the 08/21/2016 storm. See figure 4.), and again in November.

Figure 3 shows photographs during construction of the gauge signs, camera setup and water race geometry measurements for cross sectional area and flow calibration. Figure 4 shows two signs; before during and after a major storm event. Clearly a new design will be needed to protect the signs from floating logs in high water. See also figure 5 showing sign damage before and after a storm in November.

As a backup plan in case the signs would be torn from their bolts (which they ultimately were) or became unreadable because of trapped floating debris, the depth of each brick, relative to the laser level, was carefully measured and documented. The idea was that the number of bricks showing in the photographs at any water height would be manually countable in the photos and could act as a proxy depth sign. (In fact, it was this brick data which allowed measurement of the rate of the falling water line after the 08/21/2016 storm because the signs had been destroyed. See figure 4.)

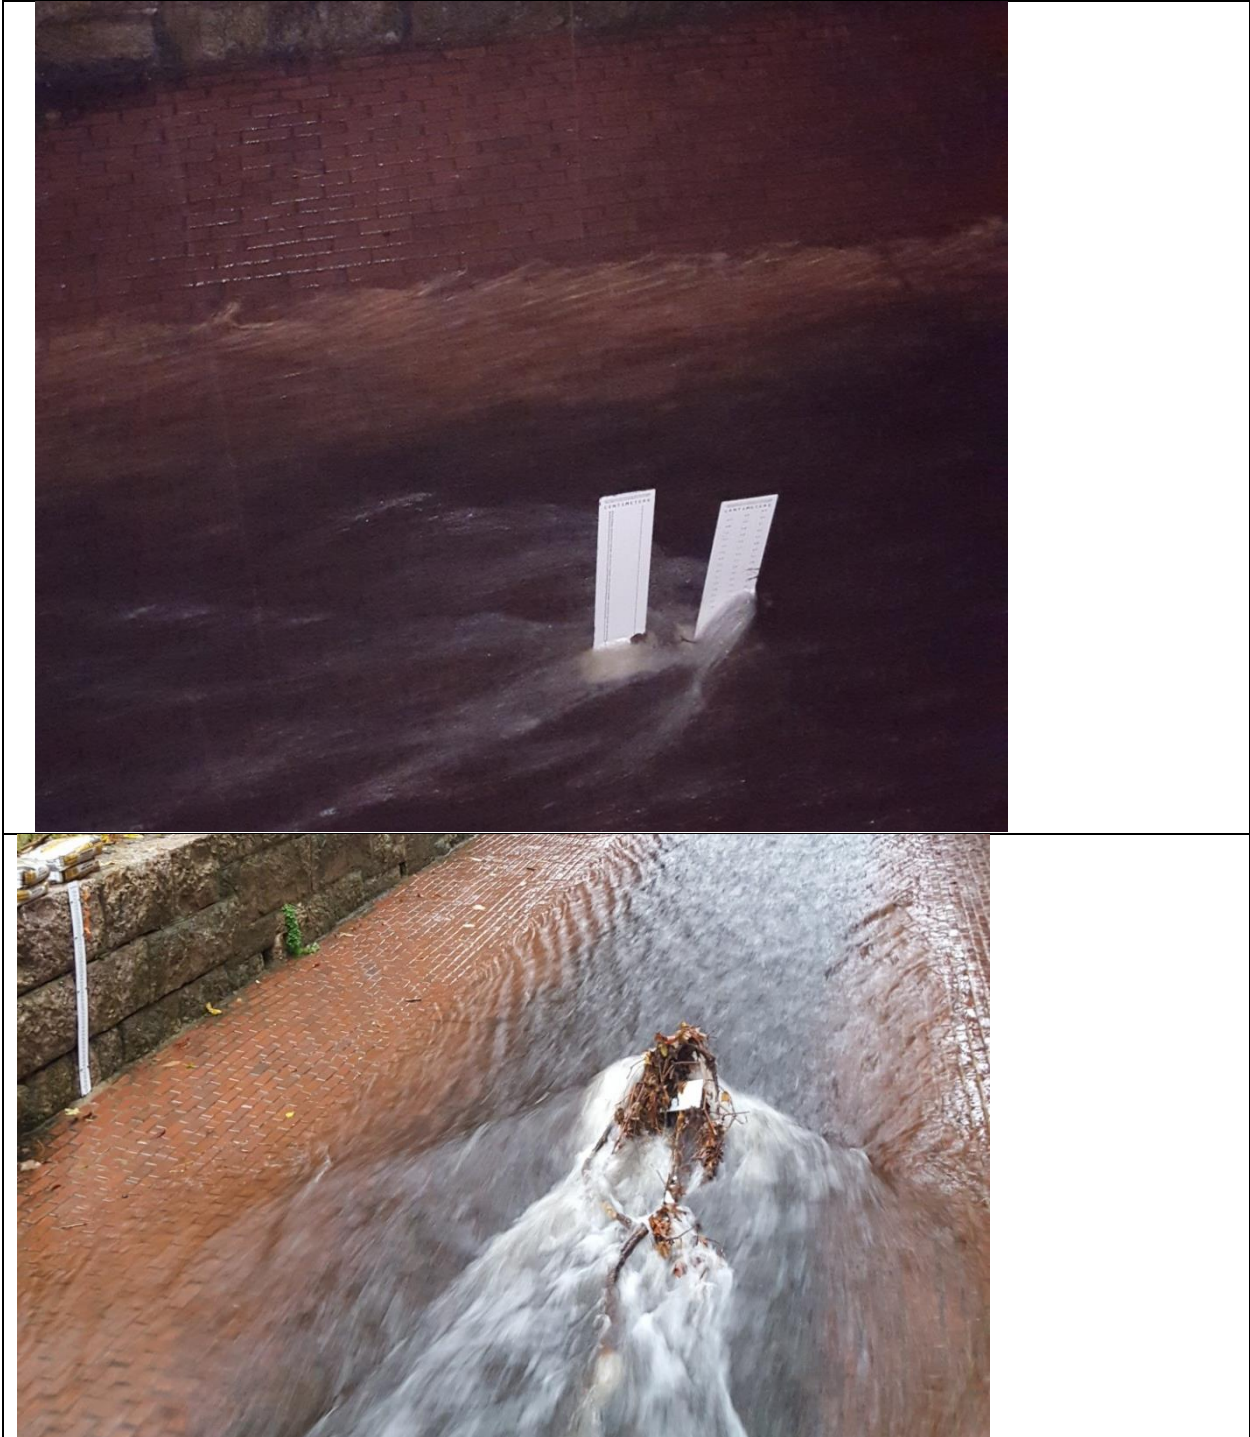
We had originally sought to have the photograph files automatically read and logged for the depth values, but this proved to be impossible due to the leaf and debris fouling. See figure 5

Figure 5: photographs of debris fouling the stage signs. A) After some impact damage and debris fouling. B) After second time signs were destroyed by impact.
