INDIAN BROOK-CROTON GORGE WATERSHED CONSERVATION ACTION PLAN

Westchester County, New York

A cooperative effort among the:
Town of Cortlandt
Village of Croton-on-Hudson
Town of New Castle
Town of Ossining
Village of Ossining
NYSDEC Hudson River Estuary Program
And Westchester County

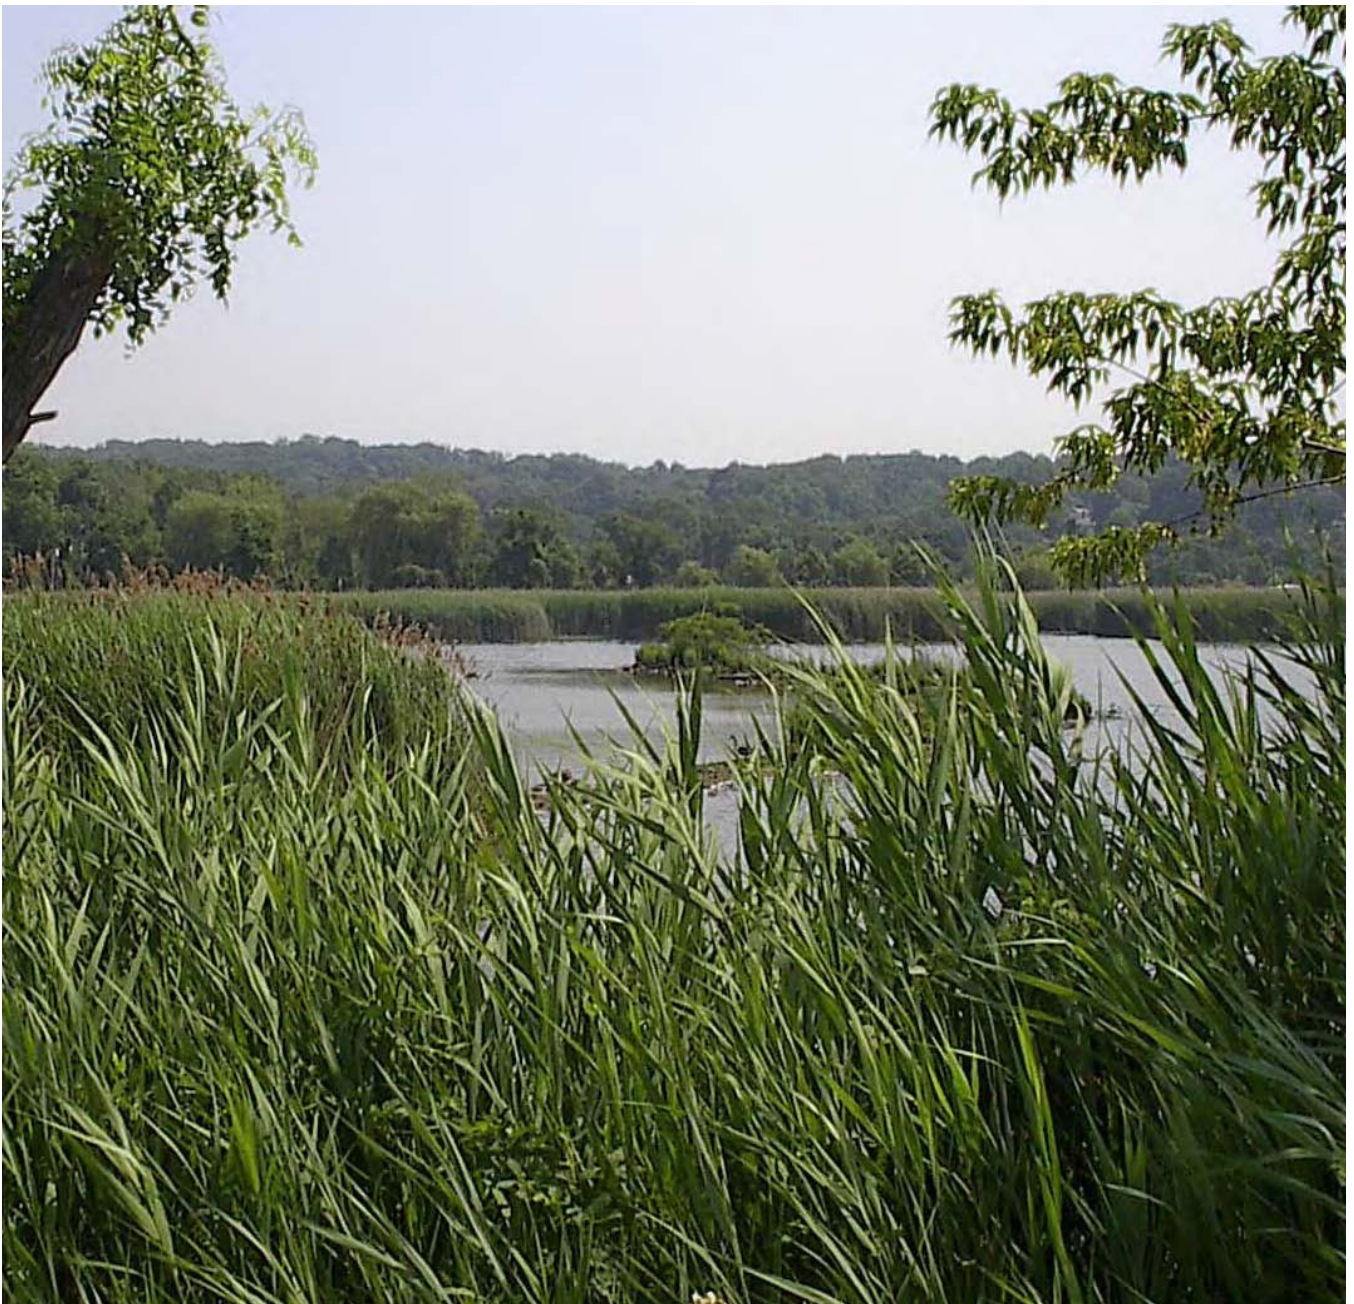
Figure 2-8. Phragmites dominated tidal wetlands of the Croton Bay

The watershed contains 73 acres of estuarine NWI wetlands, in addition to NYSDEC wetlands, that are located in the brackish tidal portions of the Croton Bay near Croton Point Park and the mouth of the Croton River. There are 128 acres of palustrine (marsh) wetlands that are found throughout the watershed. There are 38 acres of riverine wetlands; all but 2 acres are nonvegetated wetlands. Finally, the watershed contains 0.1 acres of lacustrine (lake) wetlands. Listed in Figure 2-9 are the different United States Army Corps National Wetland Inventory (NWI) wetlands that are found in the watershed.

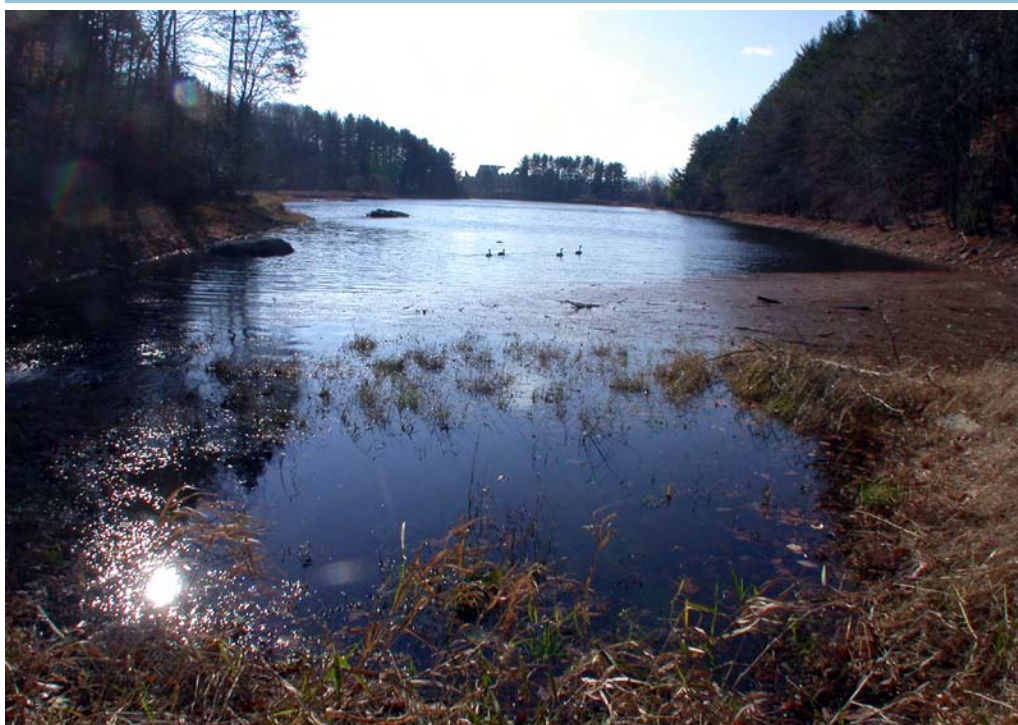
Figure 2-13. Indian Brook Reservoir, Ossining, NY

The Indian Brook Reservoir (Figure 2-13) serves as a drinking water source for the Town and Village of Ossining. In 2006, the Indian Brook Plant pumped 504.6 million gallons of water for the year. The Village owned reservoir had approximately 100 million gallon capacity. The Indian Brook Reservoir is surrounded by forest. Three inlet streams to the Reservoir and one outlet stream exist and vary between 4-10 feet wide and vary between 3-8 inches deep.

The overall water quality rating based on the Indian Brook Streamwalk for the Reservoir was good. The noted areas of concern for the Reservoir included streams that were flowing directly into it. Streambank erosion was identified along the northern inlet stream. This erosion can contribute to increased turbidity and silting of the stream and the Reservoir. The eastern inlet stream of the Reservoir was reported to have poor canopy cover, which can affect the habitat quality for stream organisms. It was also noted to exhibit poor insect and invertebrate habitat, which can affect the viability of the stream ecosystem.

Portions of the Indian Brook that run parallel to Glendale Road and eventually discharge into the Reservoir might contribute stormwater pollutants to the Reservoir. Runoff discharges into the stream during storm events through outfalls or sheet flow. Two drainage pipes that discharge untreated stormwater directly into the stream were identified along the Glendale Road segment. The first discharge pipe drains runoff from Glendale Road and the second collects runoff from surrounding residences. Other segments of the Indian Brook are located in private backyards that can also receive stormwater runoff and pollutants associated with landscape management activities.

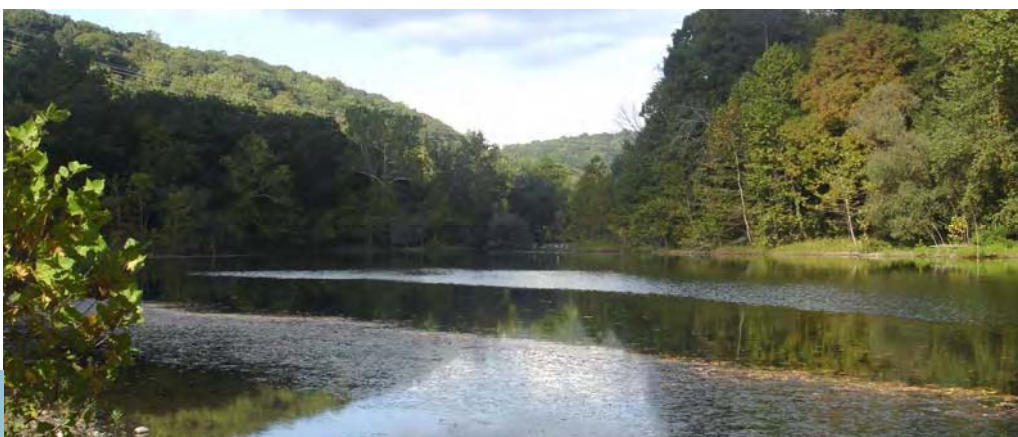
Figure 2-16. Wildlife Corridors Identified in the Indian Brook-Croton Gorge Watershed as part of the Croton-to-Highlands Biodiversity Plan

corridors are displayed in Figure 2-16 (listed as Biodiversity Hubs 11-13).

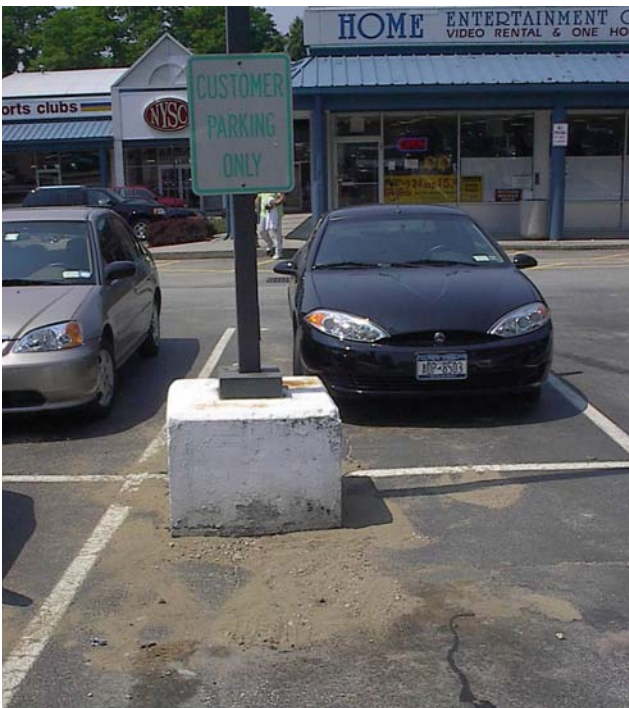
Figure 2-34.
Shop-Rite Plaza,
Croton-on-Hudson,
New York

Stormwater problem area investigations were conducted in Croton using site reconnaissance techniques. Currently, all stormwater runoff from Route 9/9A drains directly from the roadways and discharges into Croton Bay. The Shop Rite Shopping Center, located on Riverside Avenue (Figure 2-34), has a large parking lot with little pervious surface. Sediments can be found throughout the parking lot that di-

Commercial and transportation uses comprise approximately 16% of Croton. Although non-residential land uses are a small percentage of the total land area in Croton, non-residential land uses typically have large areas of impervious surfaces and onsite activities that could degrade water quality. If stormwater from these parcels is not properly controlled and treated, these parcels have the potential to contribute significant pollutants into the watershed. Major areas of concern are the shopping center located east of 9/9-A, the Metro-North train station and repair yards and Route 9/9-A.
