Monhagen Brook Watershed

Conservation and Management Plan

**Hudson River
Estuary Program**

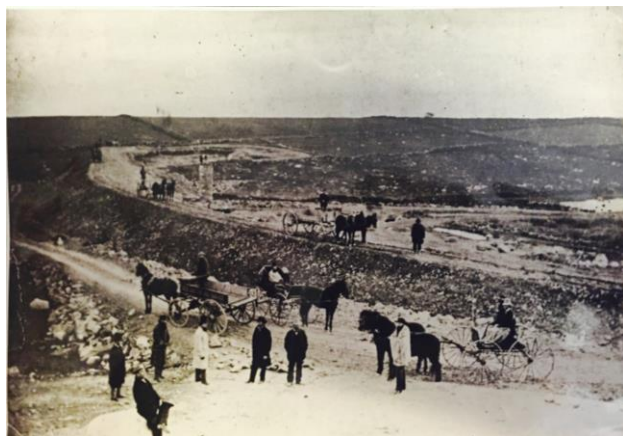
Figure 4. Building Monhagen Lake Reservoir in 1867

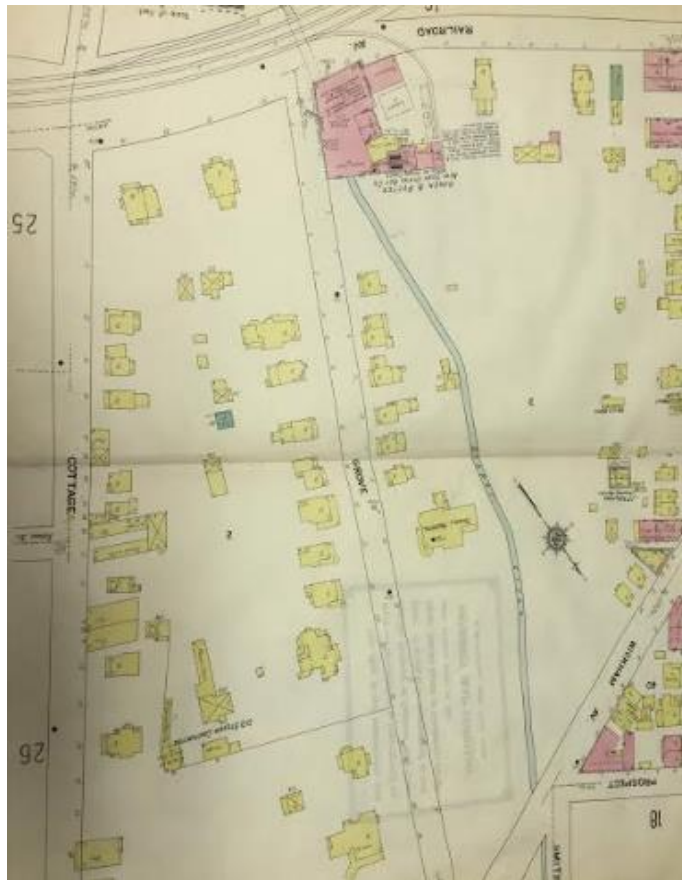
Figure 6. The Draper Brook flows through the City of Middletown, shown on historical Sanborn Map.

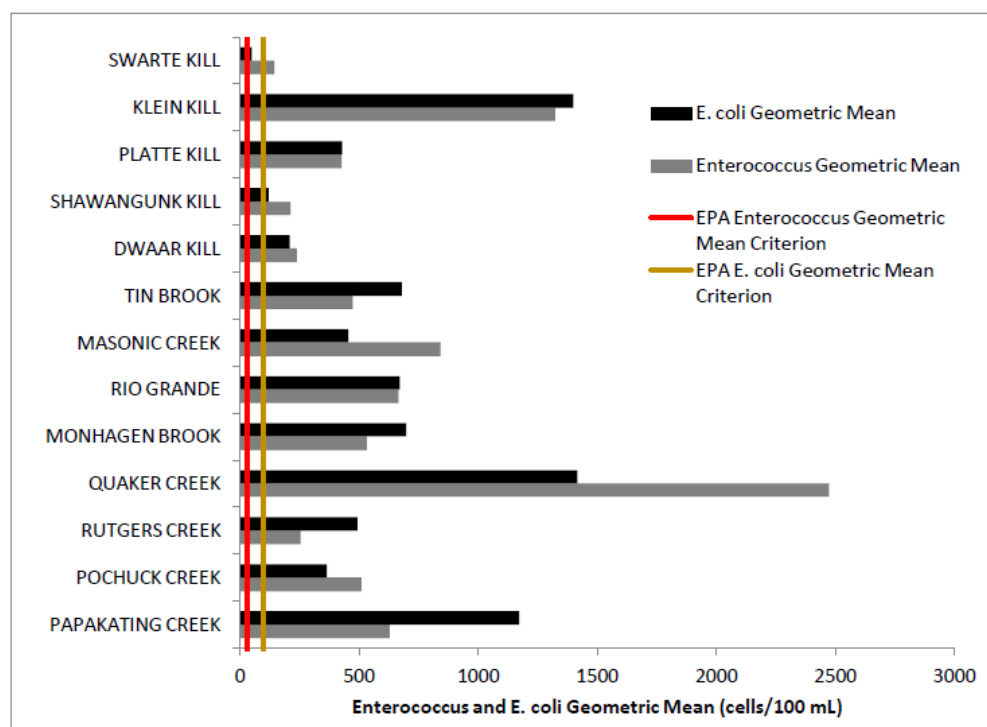
Figure 11. Comparison of Riverkeeper's results throughout the Hudson River Watershed in 2017.

In addition to the Monhagen Brook, 12 other Wallkill River tributaries were sampled in August 2016. Results are shown in Figure 11. All watersheds sampled exceeded the geometric criterion for one or both fecal-indicator bacteria. Of the 13 tributaries studied, the Monhagen Brook had the sixth-worst Entero geometric mean and the fifth-worst *E. coli* geometric mean, showing that the Monhagen Brook is an important contributor to fecal contamination in the Wallkill River, and a high priority area for eliminating fecal pollution in the Watershed.

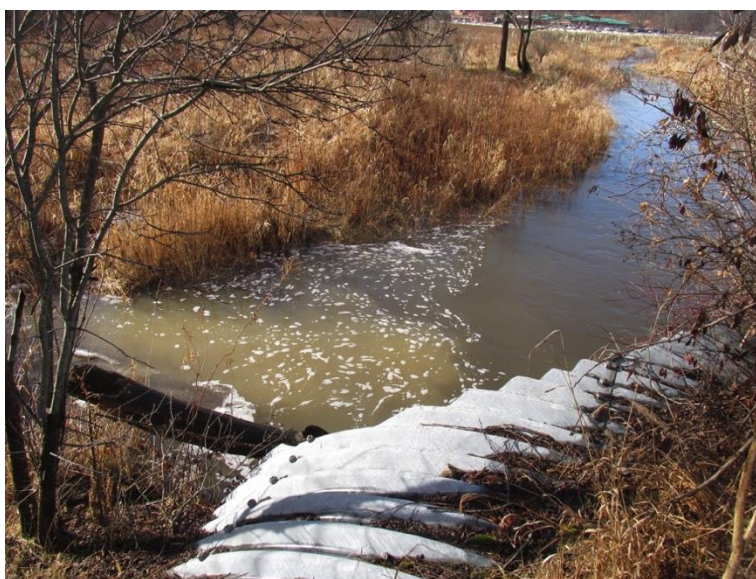
Figure 17. A nearby construction site causes a silt plume in a tributary of the Monhagen Brook in 2018. The site had erosion and sediment control measures in place, but they were not installed properly.

A more important stormwater-related contributor to phosphorus in the Watershed is erosion from construction sites with insufficient control measures. Current NYSDEC stormwater regulations require any construction site disturbing more than one acre to gain coverage under a stormwater construction general permit, and to prepare and implement an erosion and sediment control plan. However, as demonstrated in Figure 17, large amounts of sediment can still leave a construction site during a rain event and quickly end up in a stream or other waterbody when approved control measures are not installed, monitored, and/or maintained correctly. These poorly managed construction sites could result in erosion rates of up to 100 tons of soil per acre per year. While these rates of erosion would likely be vastly reduced once the construction phase is completed and the site is vegetated, built, or otherwise stabilized, significant water quality impacts result from these short term, high rates of erosion.

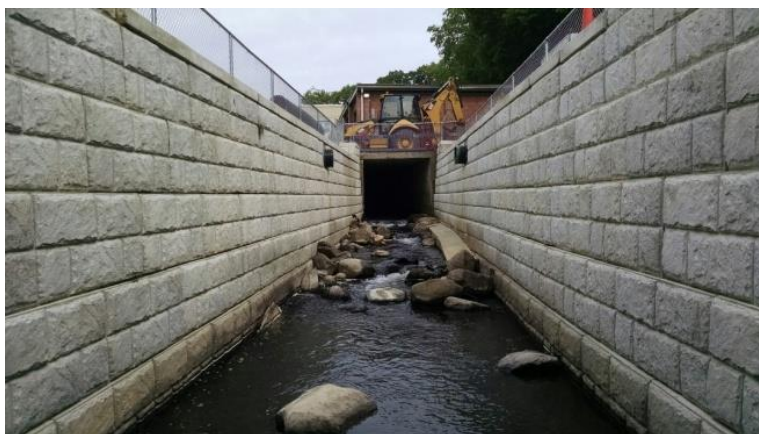
Figure 19. This section of the Brook east of Monhagen Avenue in Middletown “daylights” for a short run before returning underground. The pre-cast concrete block walls typify the extension of grey infrastructure techniques beyond the streets, catch basins, and collection systems to the stream itself.

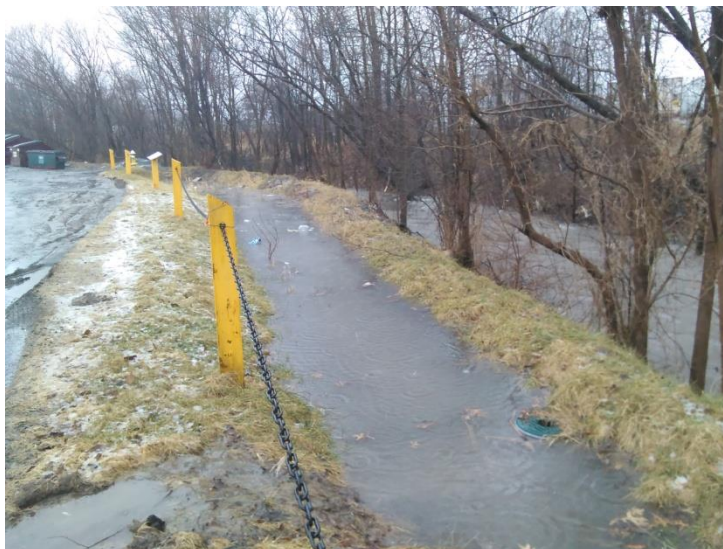
Figure 20. Parking lot runoff is collected and treated by this Bioretention Basin retrofit in the City of Middletown. Before the retrofit, the runoff drained directly into the Monhagen Brook, seen in the right of the photo. Measures such as this can be expected to remove about 40% of the phosphorus from the runoff stream. Similar removal rates can be expected for other dissolved pollutants.

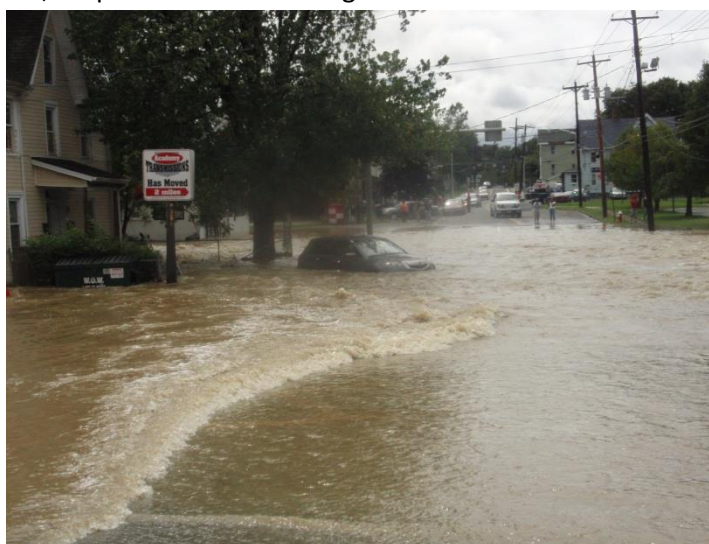
Figure 21. Floodwaters at the intersection of Fulton and Academy Streets during Hurricane Irene in 2011.

Where the Monhagen is buried and flows under Fulton Street, the force of the floodwaters ruptured the box culverts and the roadway above. After floodwaters subsided, the road collapsed into huge craters created by the damaged culverts. Businesses in the center of Middletown were without power for nearly a week. After the storms, Middletown developed a list of damages to its public infrastructure, including roadways, culverts, and City facilities that totaled \$7,134,800. Private property damages were substantial.

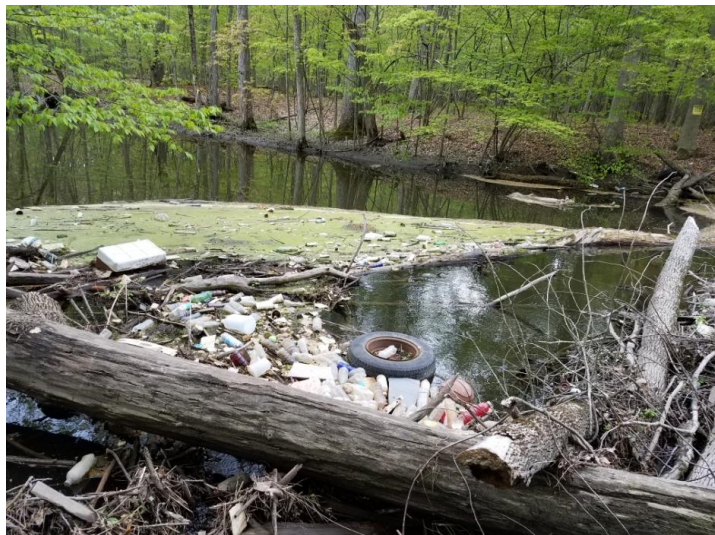
Figure 23. Garbage collected behind a log jam on the Monhagen Brook. Woody material is generally good for the health of the stream, whereas the garbage is obviously not.

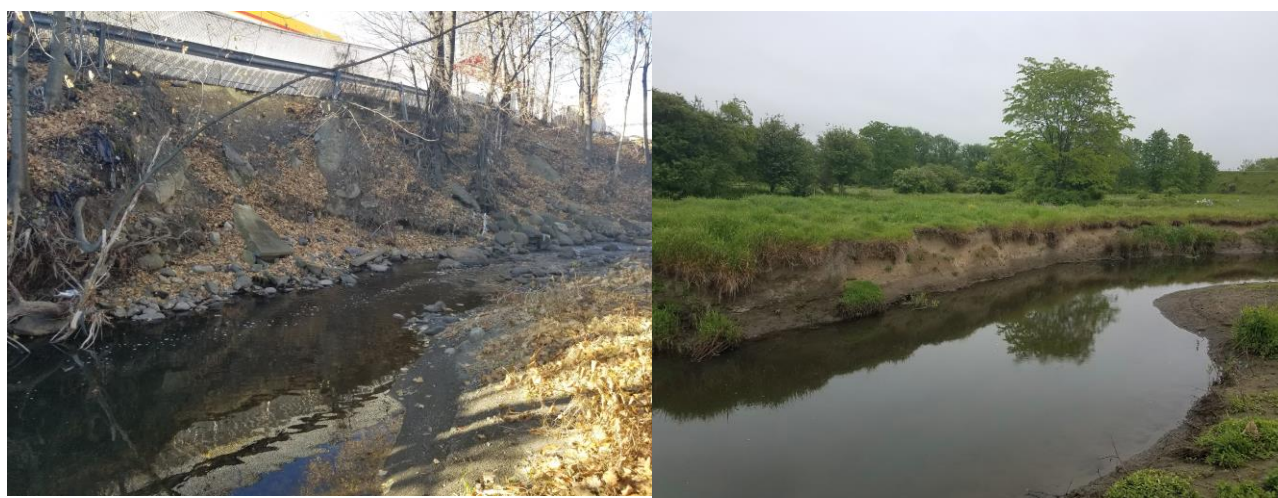
Figure 24. Severe streambank erosion near Shell gas station on the corner of Dolson Avenue and Dolsontown Road.

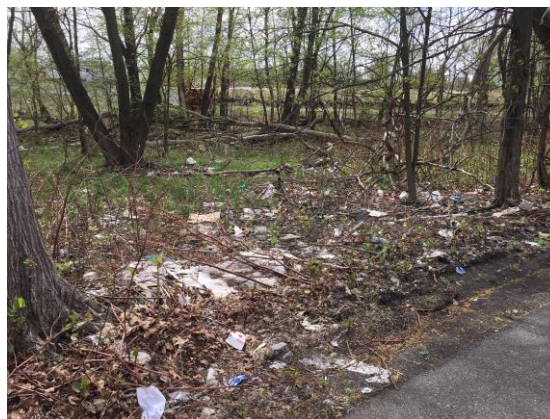
Figure 26. Litter fills the forest floor from the edge of a commercial parking lot to the Monhagen Brook in the background.

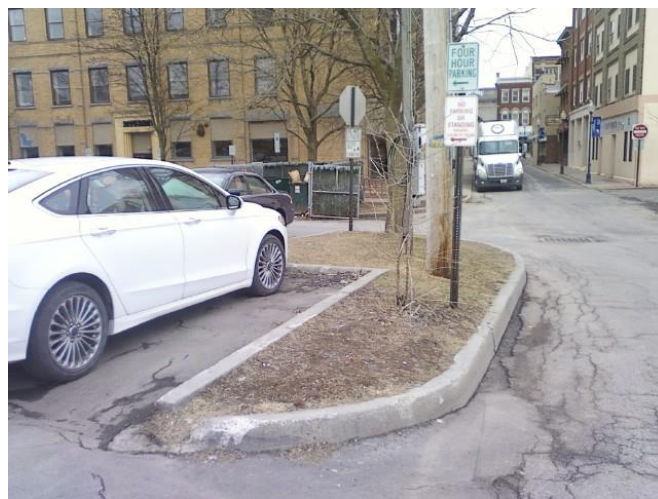
Figure 27. Parking lot islands, like this one in the James Street parking lot, will be depressed below rather than elevated above the adjacent pavement when the lot is retrofitted. Runoff from the pavement will then flow into the island and be cleansed and filtered by soil and vegetation. The dumpsters in the background have already been relocated from the parking lot.

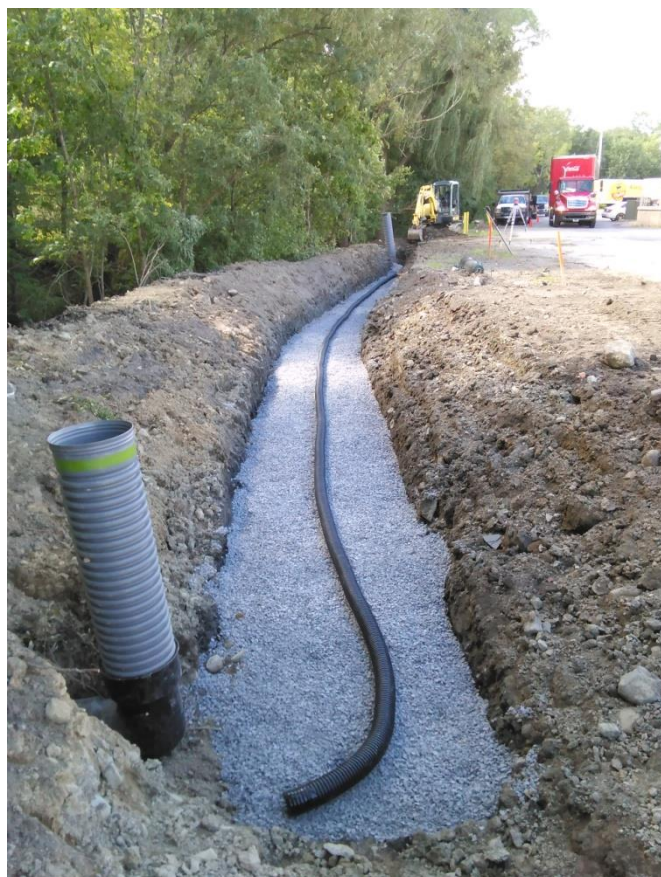
Figure 28. Construction of the Campbell Plaza Bioretention Basin

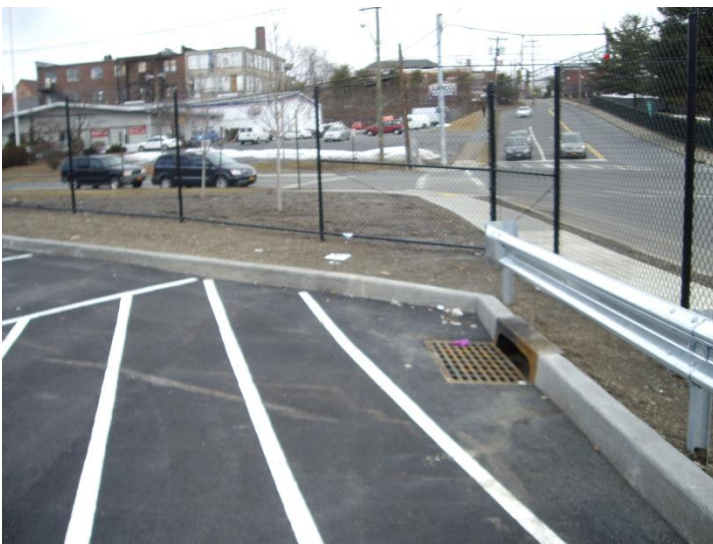
Figure 30. This site demonstrates some of the characteristics that make for a feasible potential storm water retrofit project.

The accompanying photo of the US Post Office on Fulton Street in Middletown provides an example

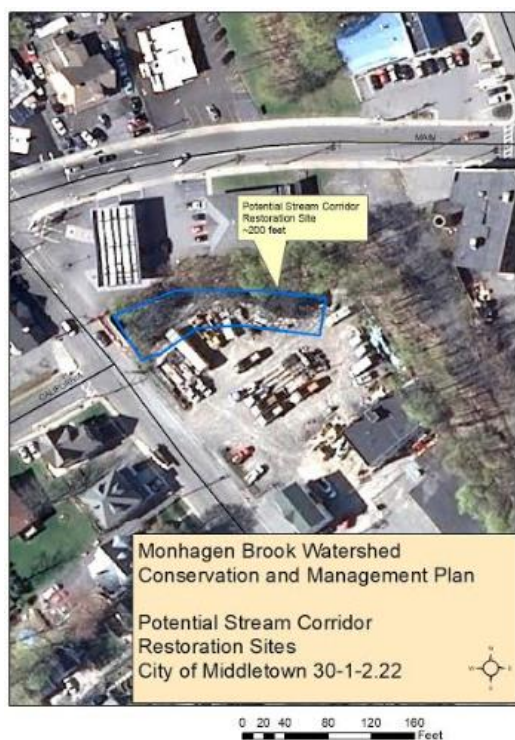
Figure 32. Stream corridor restoration opportunity at Monhagen Ave in the City of Middletown.

Downstream from Monhagen Avenue, the channel is open for 200 feet before entering a buried section. The north side of the channel is a very steep slope bordering a gas station, which offers little opportunity for corridor enhancement. The south side, however, adjacent to the landscape business, is a much lower bank and could be more feasibly restored if the business/landowner were able

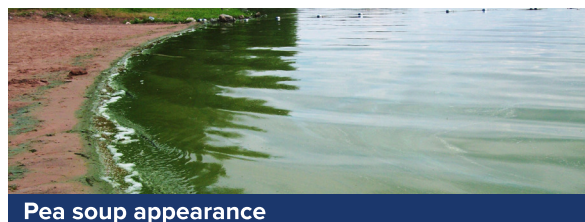
Pea soup appearance

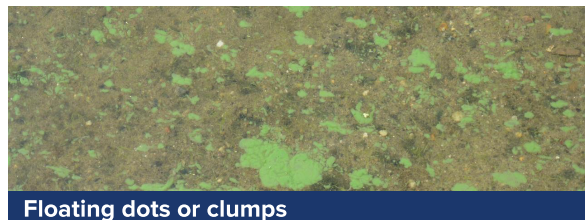
Floating dots or clumps

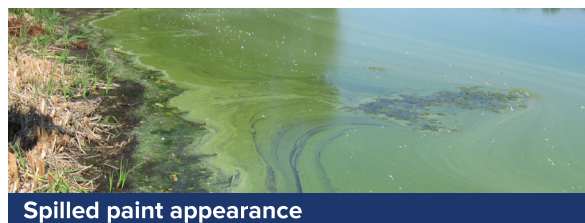
Spilled paint appearance

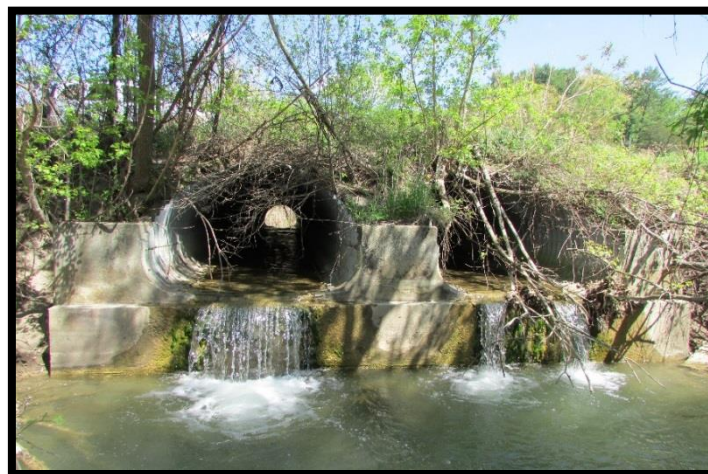
Culverts such as this one constrict the natural flow of the stream, have a perched outlet that only strong swimmers can jump and contain no natural streambed. Many culverts and dams fragment stream habitats.

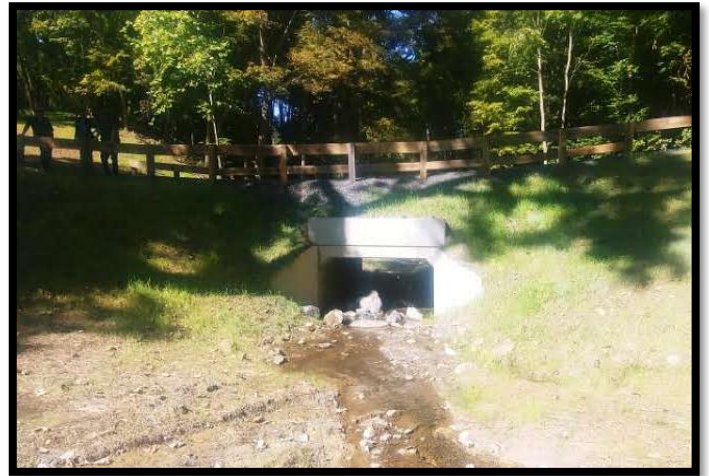
Scenic Hudson Land Trust received a grant to improve the aquatic organism passability and reduce the flooding hazard of this vital piece of infrastructure.

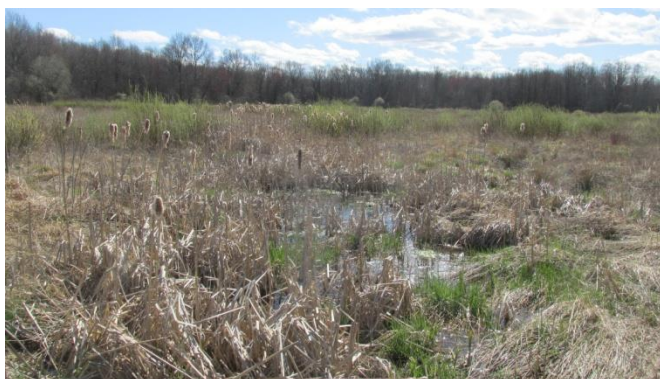
MD-28 is a 50-acre, Class 3 wetland that occurs entirely on the south side of county Rte. 56 on the Official Map, but extends onto the north side on the Additions Map. The Additions map also extends the wetland considerably to the west, across an unnamed tributary of the Monhagen Brook.

Cattails, willows, cool season grasses, and open water characterize about 23 acres of MD-28.

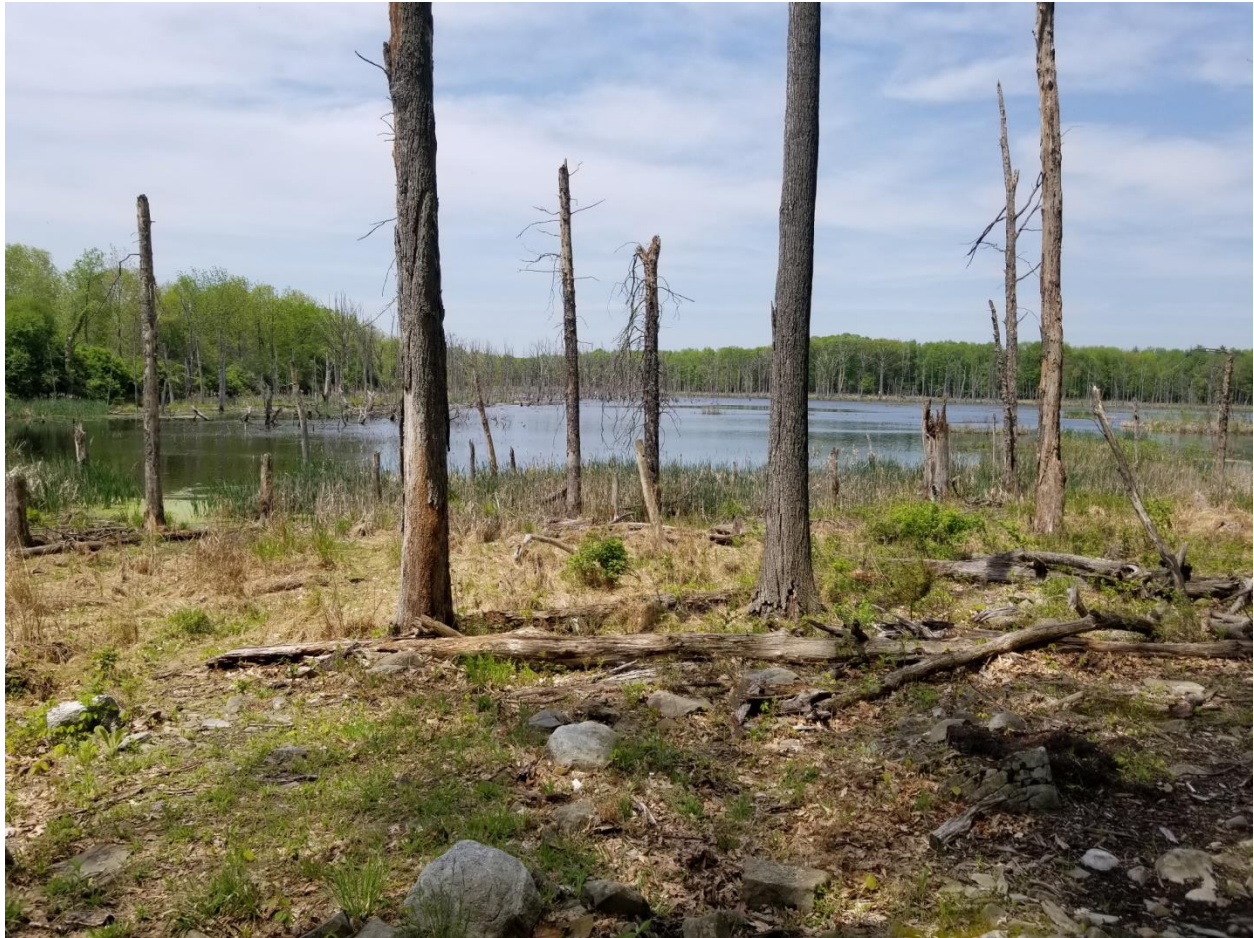
MD-13 – The open water roughly corresponds with the portion of the wetland mapped as *Histic Humaquepts* in the Orange County Published Soil Survey. The invasive plants multiflora rose and Japanese barberry were observed at this site, though not in abundance. The view is from the City of Middletown's Fancher-Davidge Park nature trail.

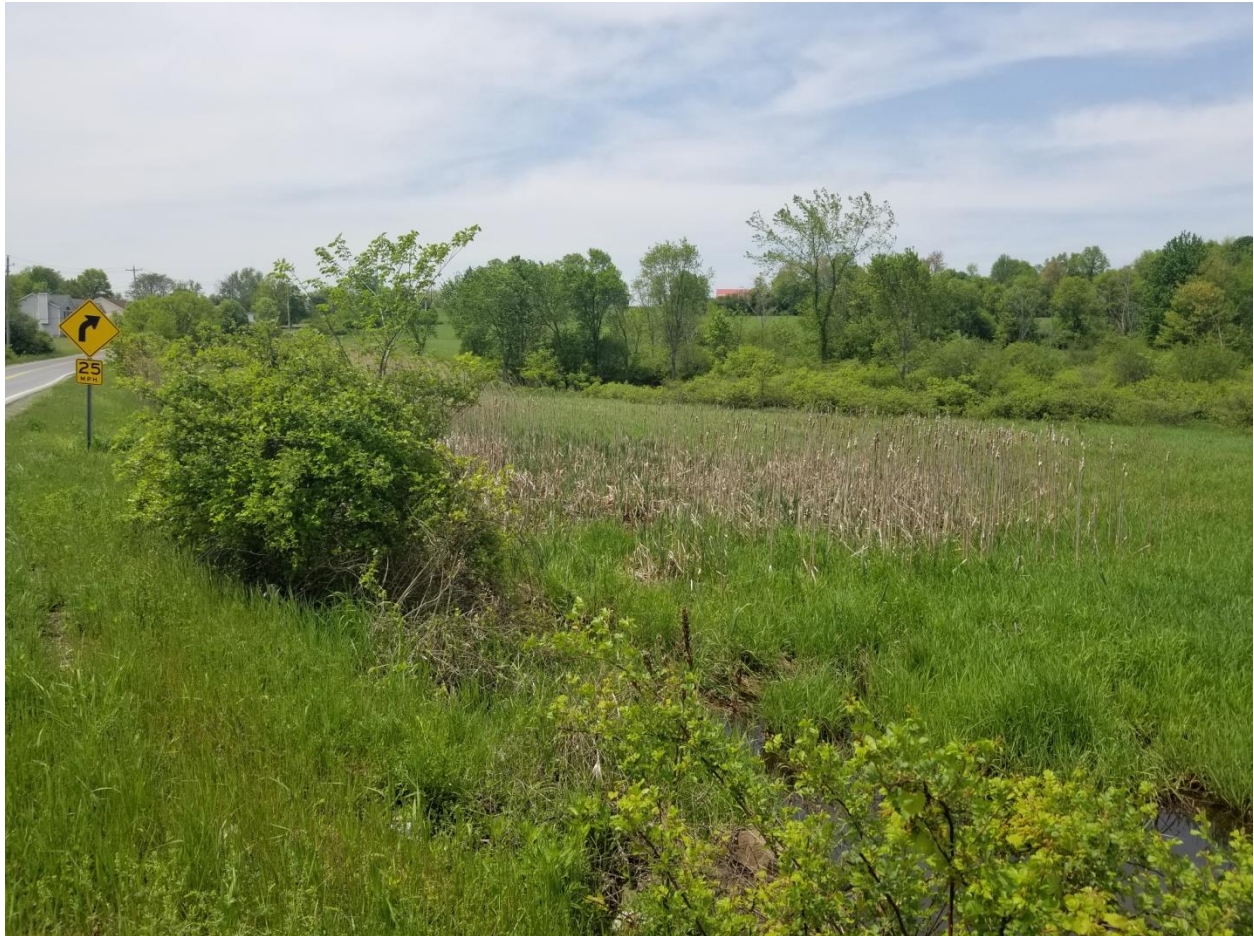
MD-19, looking west next to Genung Street. Cattails compete with a dense stand of what is thought to be reed canarygrass.
